Cala Homes

Land at Fiery Hill Road

Highways Review

Job Title	Land at Fiery Hill Road		
Job Number	J322540	Date	15/12/2015
Copy	Copy	File reference	151112 322540 AY
Prepared by	Alan Young	Approved by	David Frisby
Subject	Highways Review

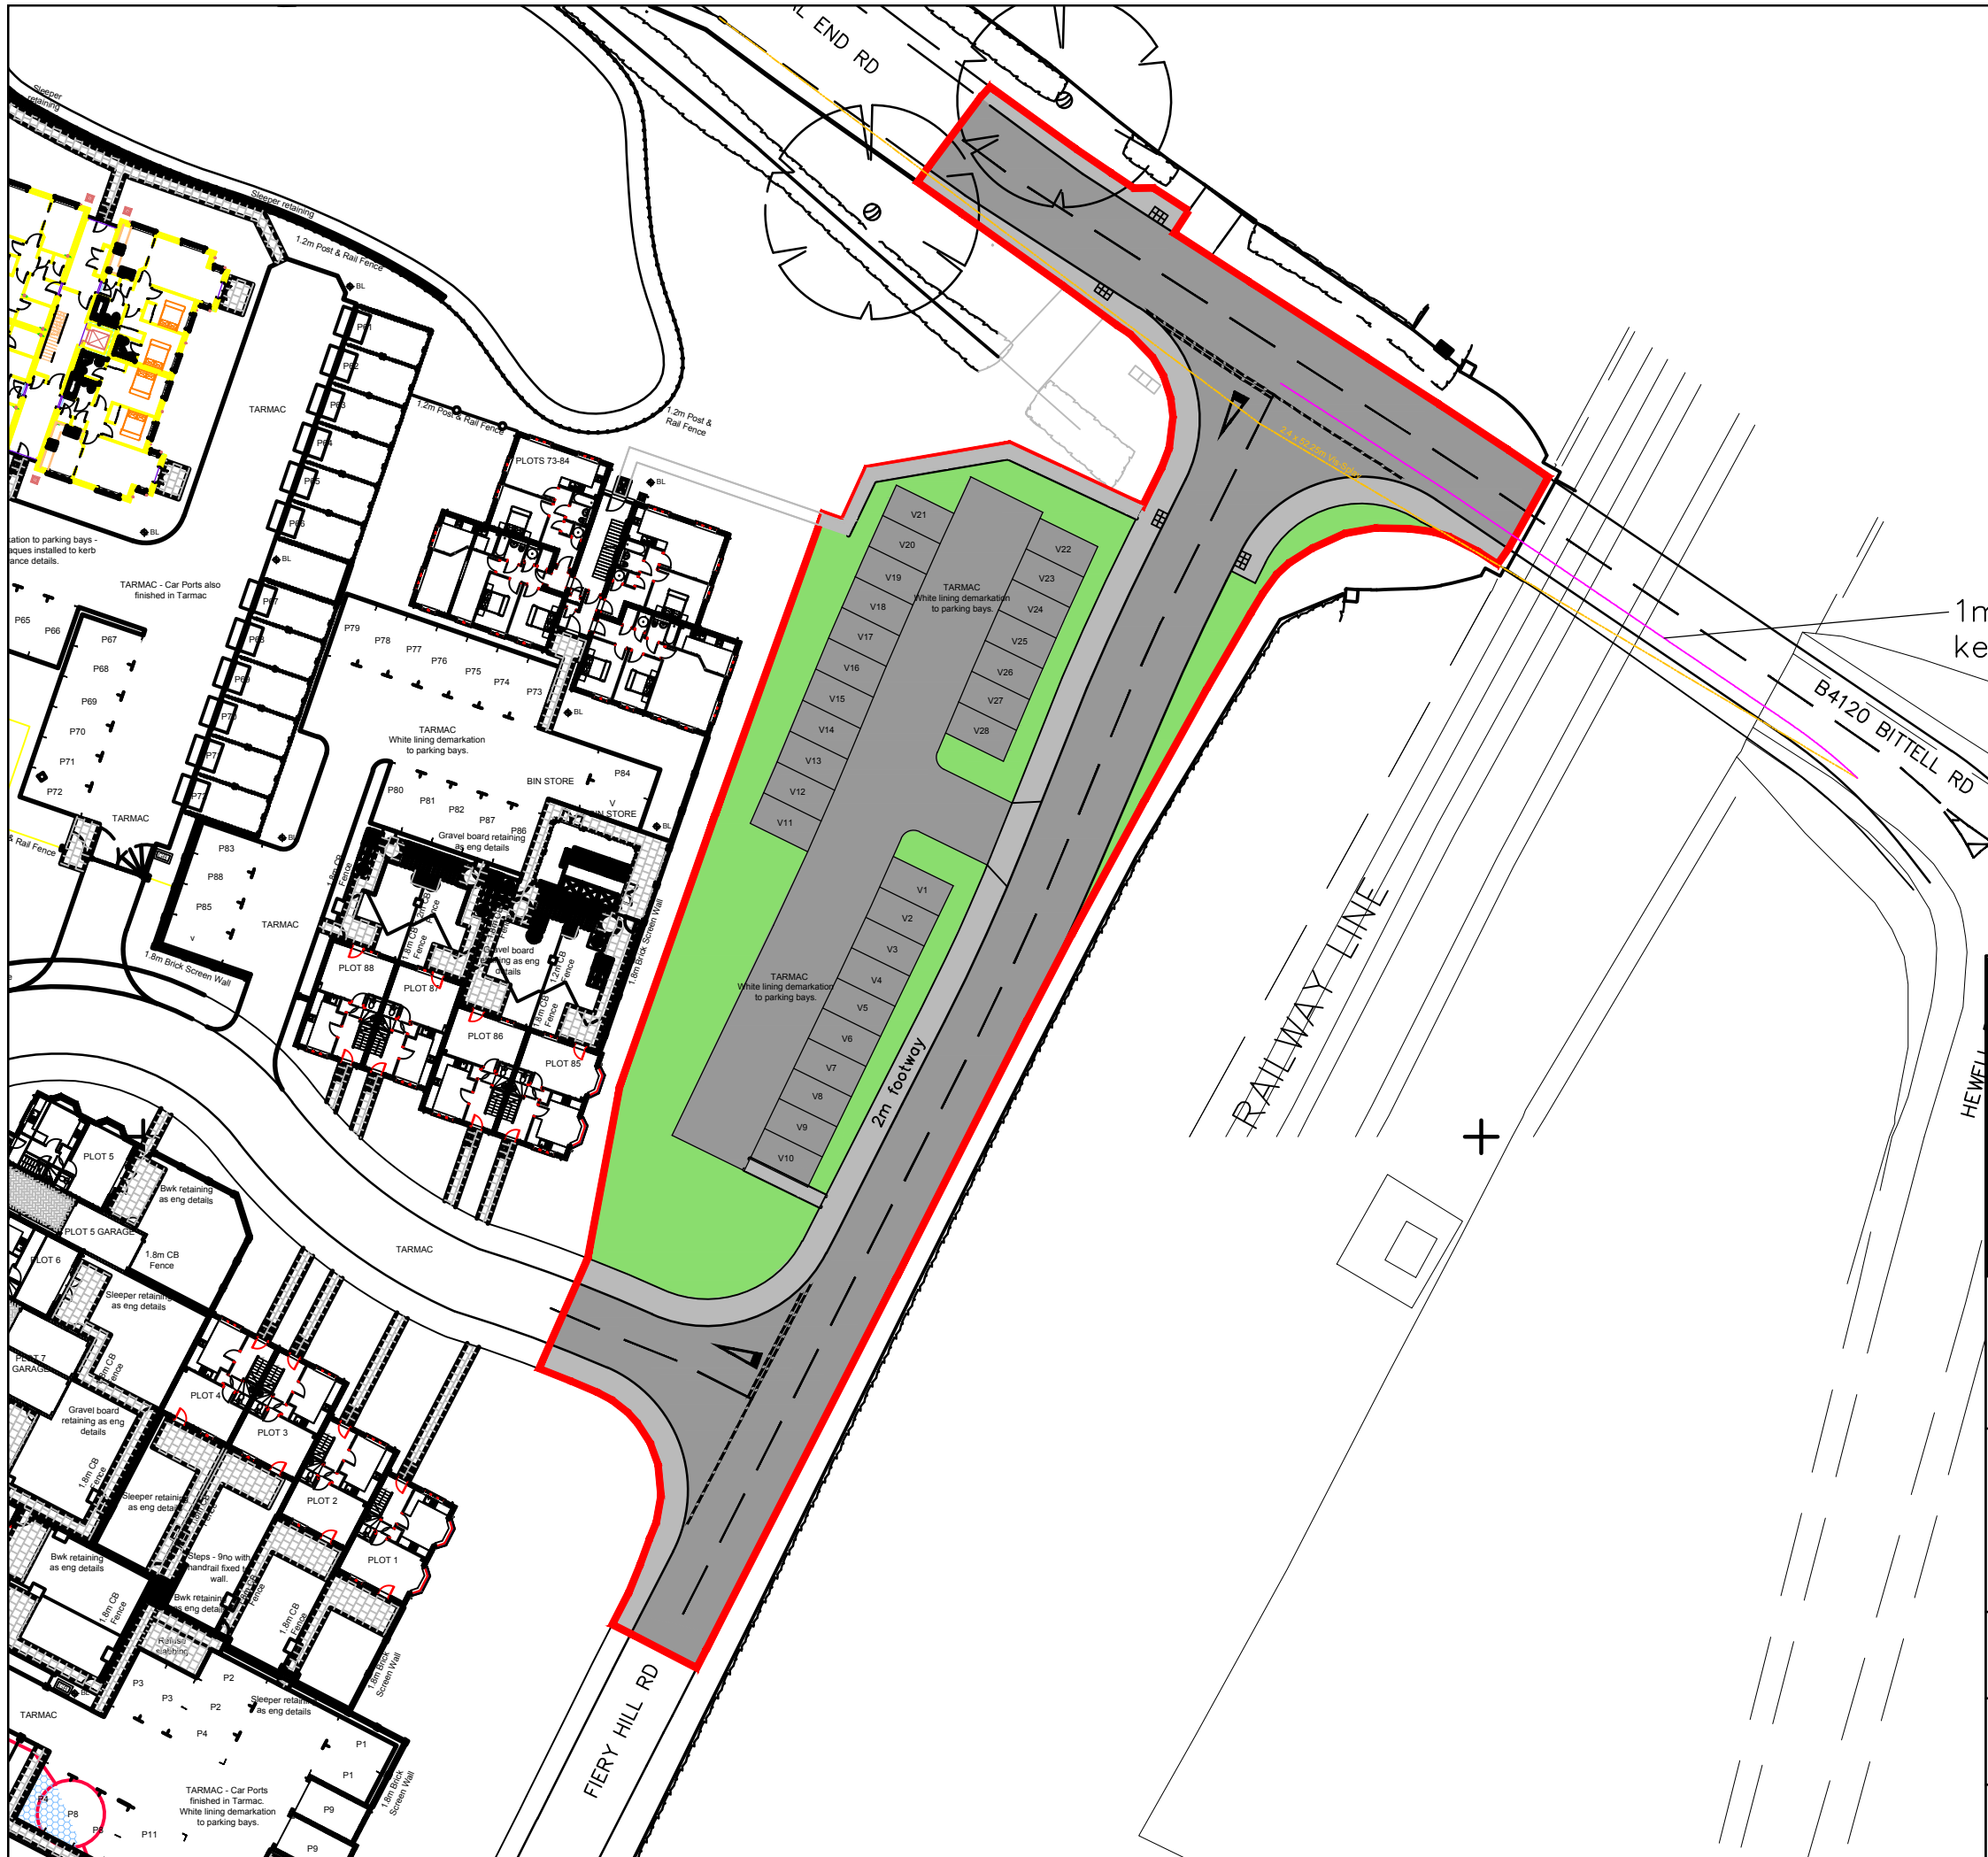
1m from
kerb line

B4120 BITTELL RD

FIERY HILL RD

CALA House Arleston Way Solihull B90 4LH Tel: 0121 711 5310 Fax: 0121 711 5311	
Site: Land off Fiery Hill Road Barnt Green			
Drawing Title: Fiery Hill Road Realignment Visibility to Vehicle Track			
Drawing No: M00311\S278\101			
Revision: -		Scale: 1:500 @ A3	
Date: 24.11.2015		Drawn: CB

- 2.1 The Transport Assessment (April 2013 page 4, para 2.3.1) records that the current visibility splay is of 20m due to the lack of a footway under the southern side of the bridge. However this matter will be significantly improved with the footway being relocated to the southern side of the bridge (April 2013 page 4, para 4.2.2); Cala Homes drawing **M00311/S278/100** identifies an achievable visibility splay of 2.4m x 45m to the kerb with the relocation of the footway.

- 2.2 *“Manual for Streets”* allows for an increase in the Y-Distance element of the visibility splay over that previously used, by measuring to the near side running track of the carriageway, approximately 1m from the kerb (ref; MfS2 page 76 and MfS2 para 10.5.3). In paragraph 10.5.3 MfS2 states, *‘Therefore a more accurate assessment of visibility splay is made by measuring to the nearside edge of the vehicle track.’* The argument being that drawing visibility splays to kerbs was always a matter of convenience for design purposes and that in reality cars and motorcycles do not physically drive along the kerb. Furthermore, MfS1 and MfS2 contain formula to be applied to the actual measured speeds at a specific location rather than having to rely on a speed limit.

- 2.3 A recent speed survey conducted at the site (11th to 17th November 2015) gives a 7 day 85th percentile speed of just 27mph for vehicles approaching the Fiery Hill Road junction from the bridge. Applying the MfS formula to this speed gives a Y-Distance of 34.5m. Measuring out 1m from the kerb would increase the current 20m Y-Distance referred to above to an achievable visibility of 30m, just short of the 34.5m required by MfS.

- 2.4 As discussed above the 7-day 85th percentile speed from the survey is 27mph, however this increased on a Sunday to 33.1mph. Therefore, to ensure that visibility splay assumptions are robust we have also assessed this higher speed using the formula for visibility included in MfS which gives a visibility splay of 47m or 49.4 allowing for the bonnet of a vehicle. Figure **M00311/S278/101** shows that measuring 1m out to the nearside running track gives a visibility splay of 52.25m, thereby demonstrating that even with the higher speeds the junction meets current design standards.

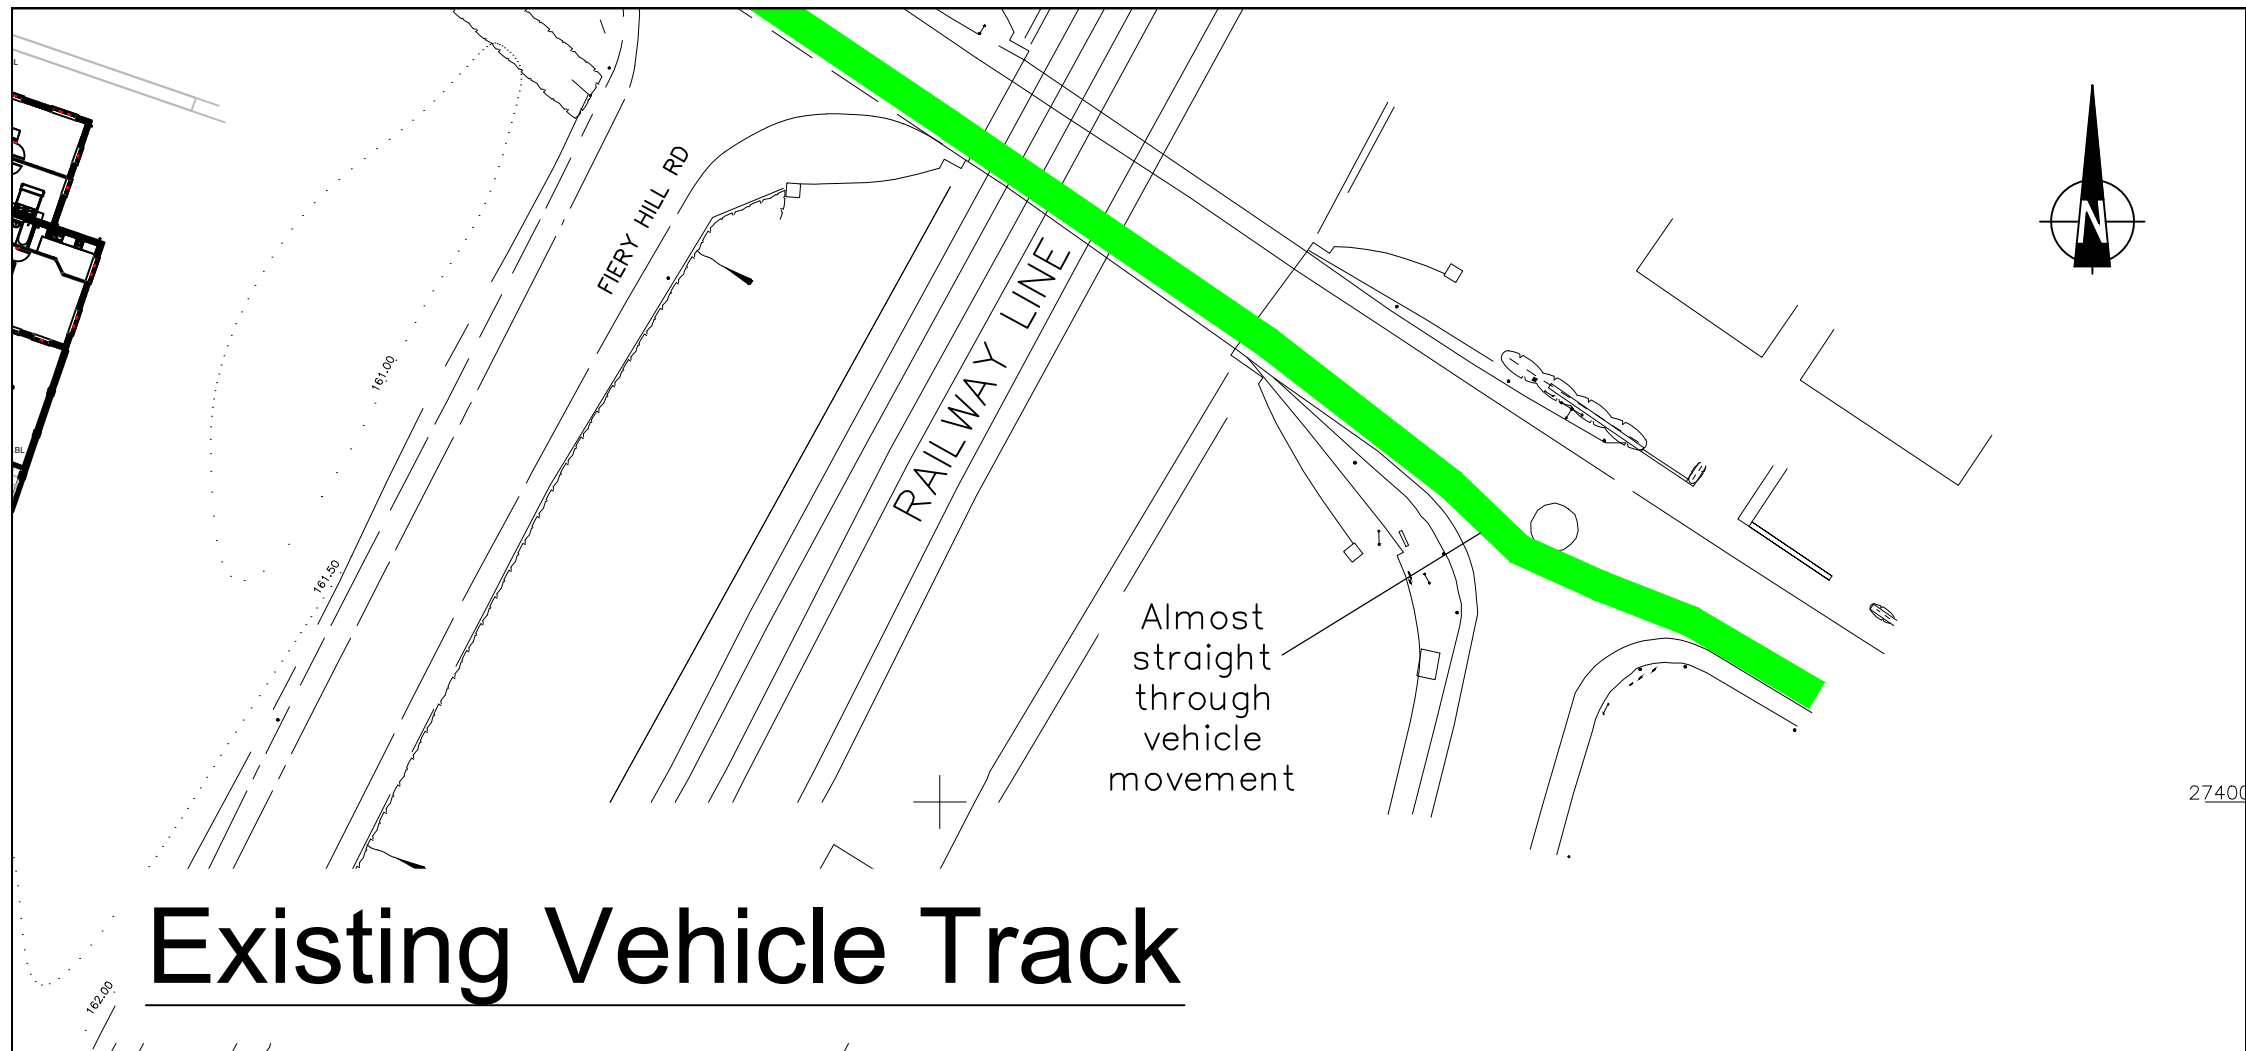
Existing Vehicle Track

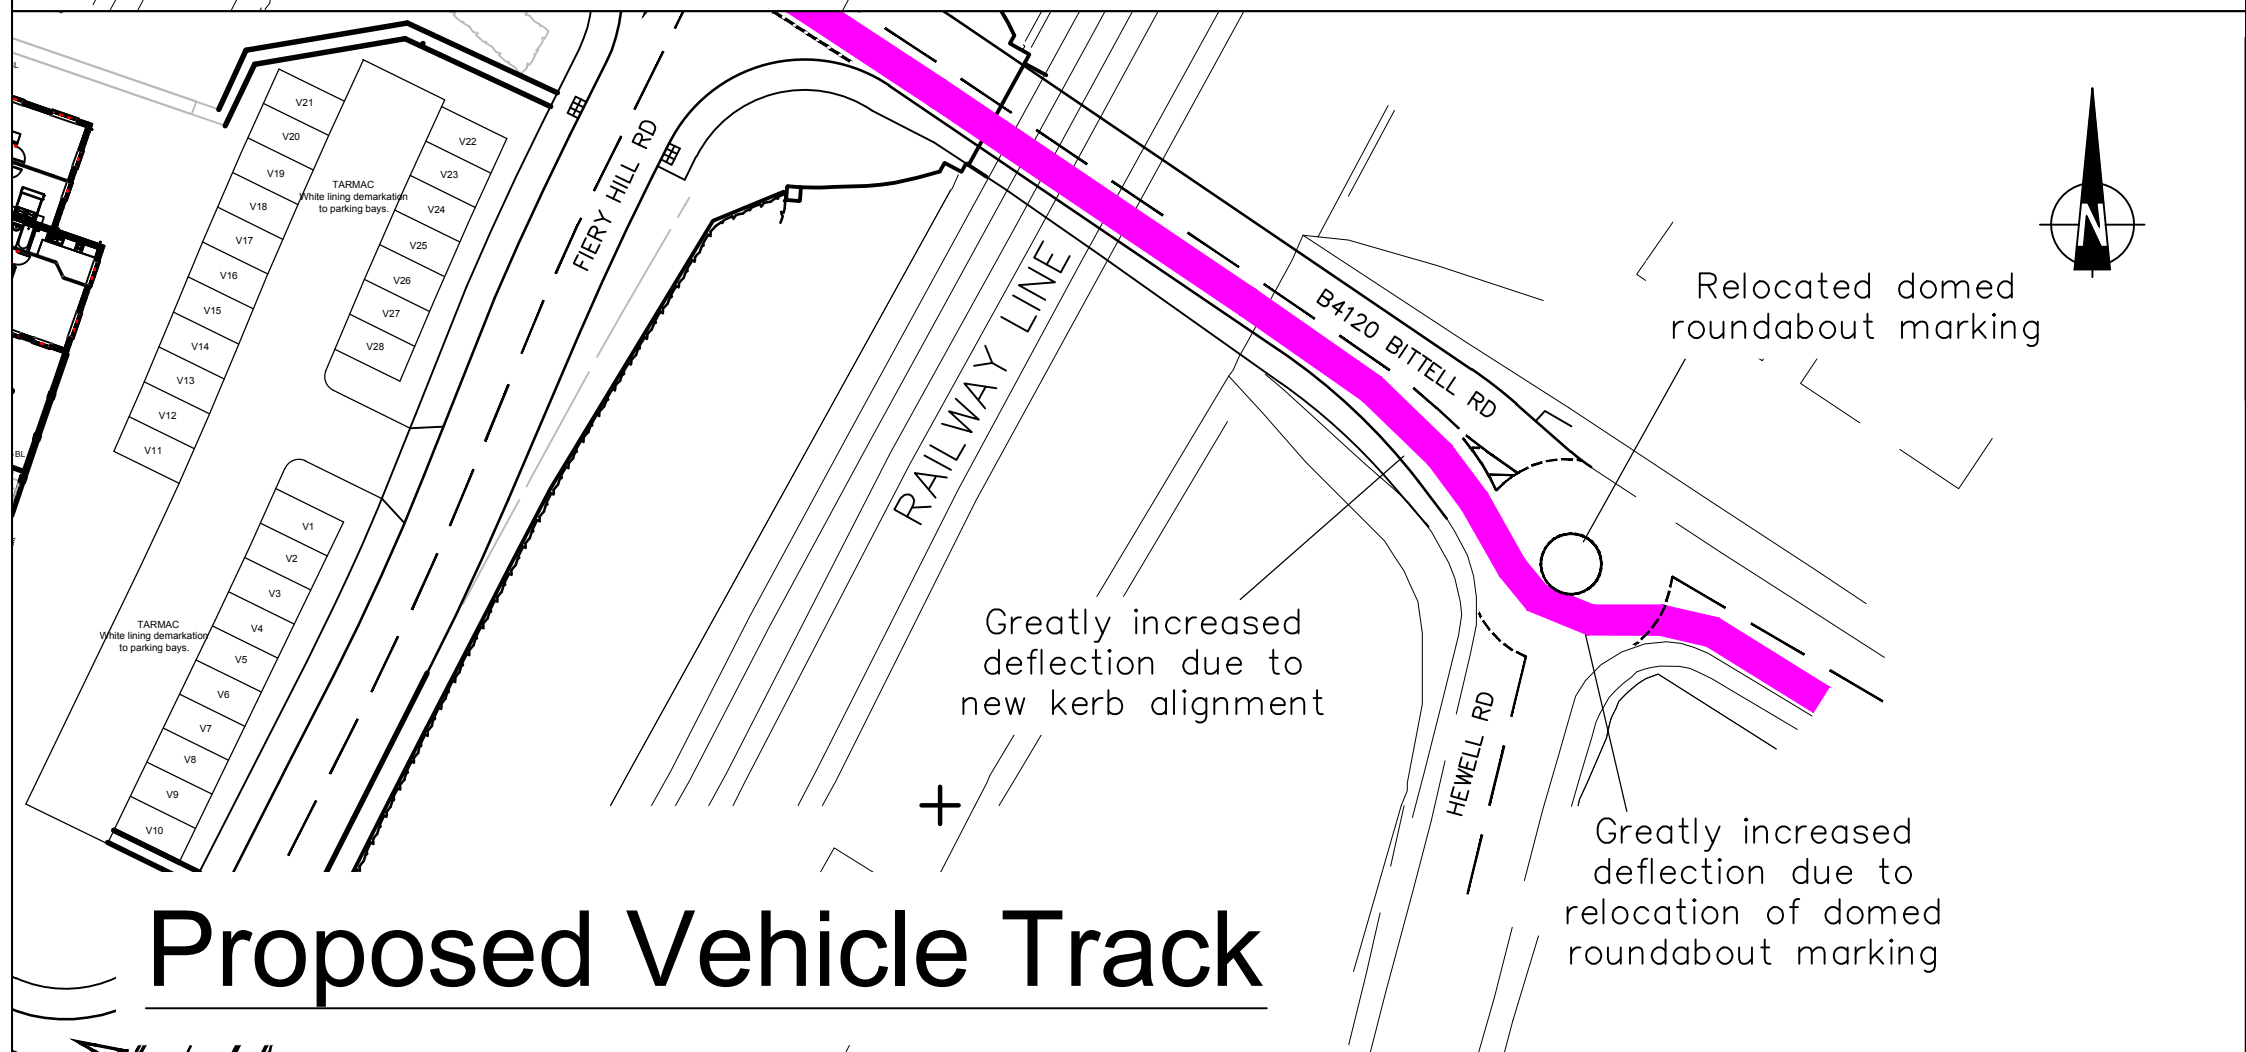
Proposed Vehicle Track

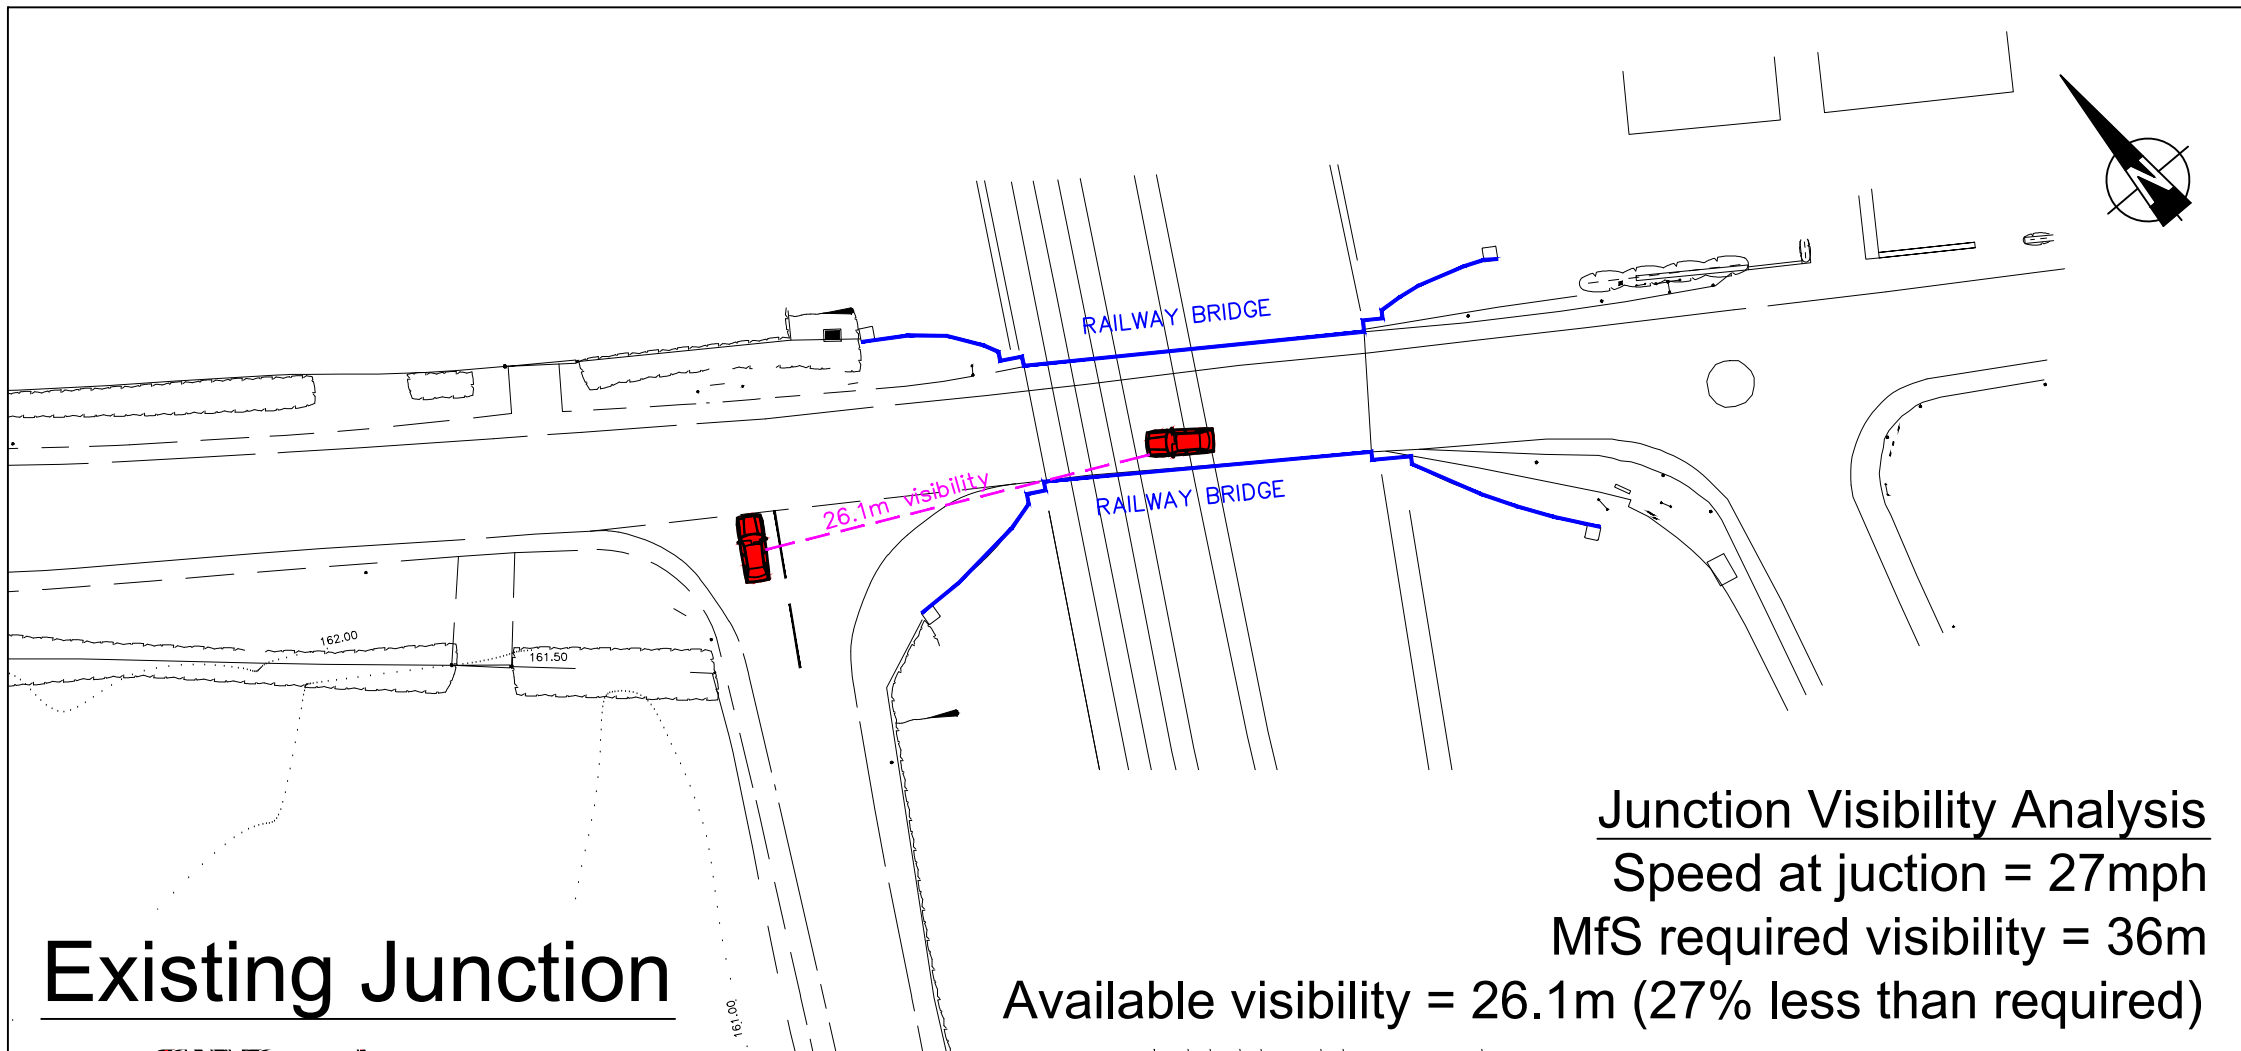
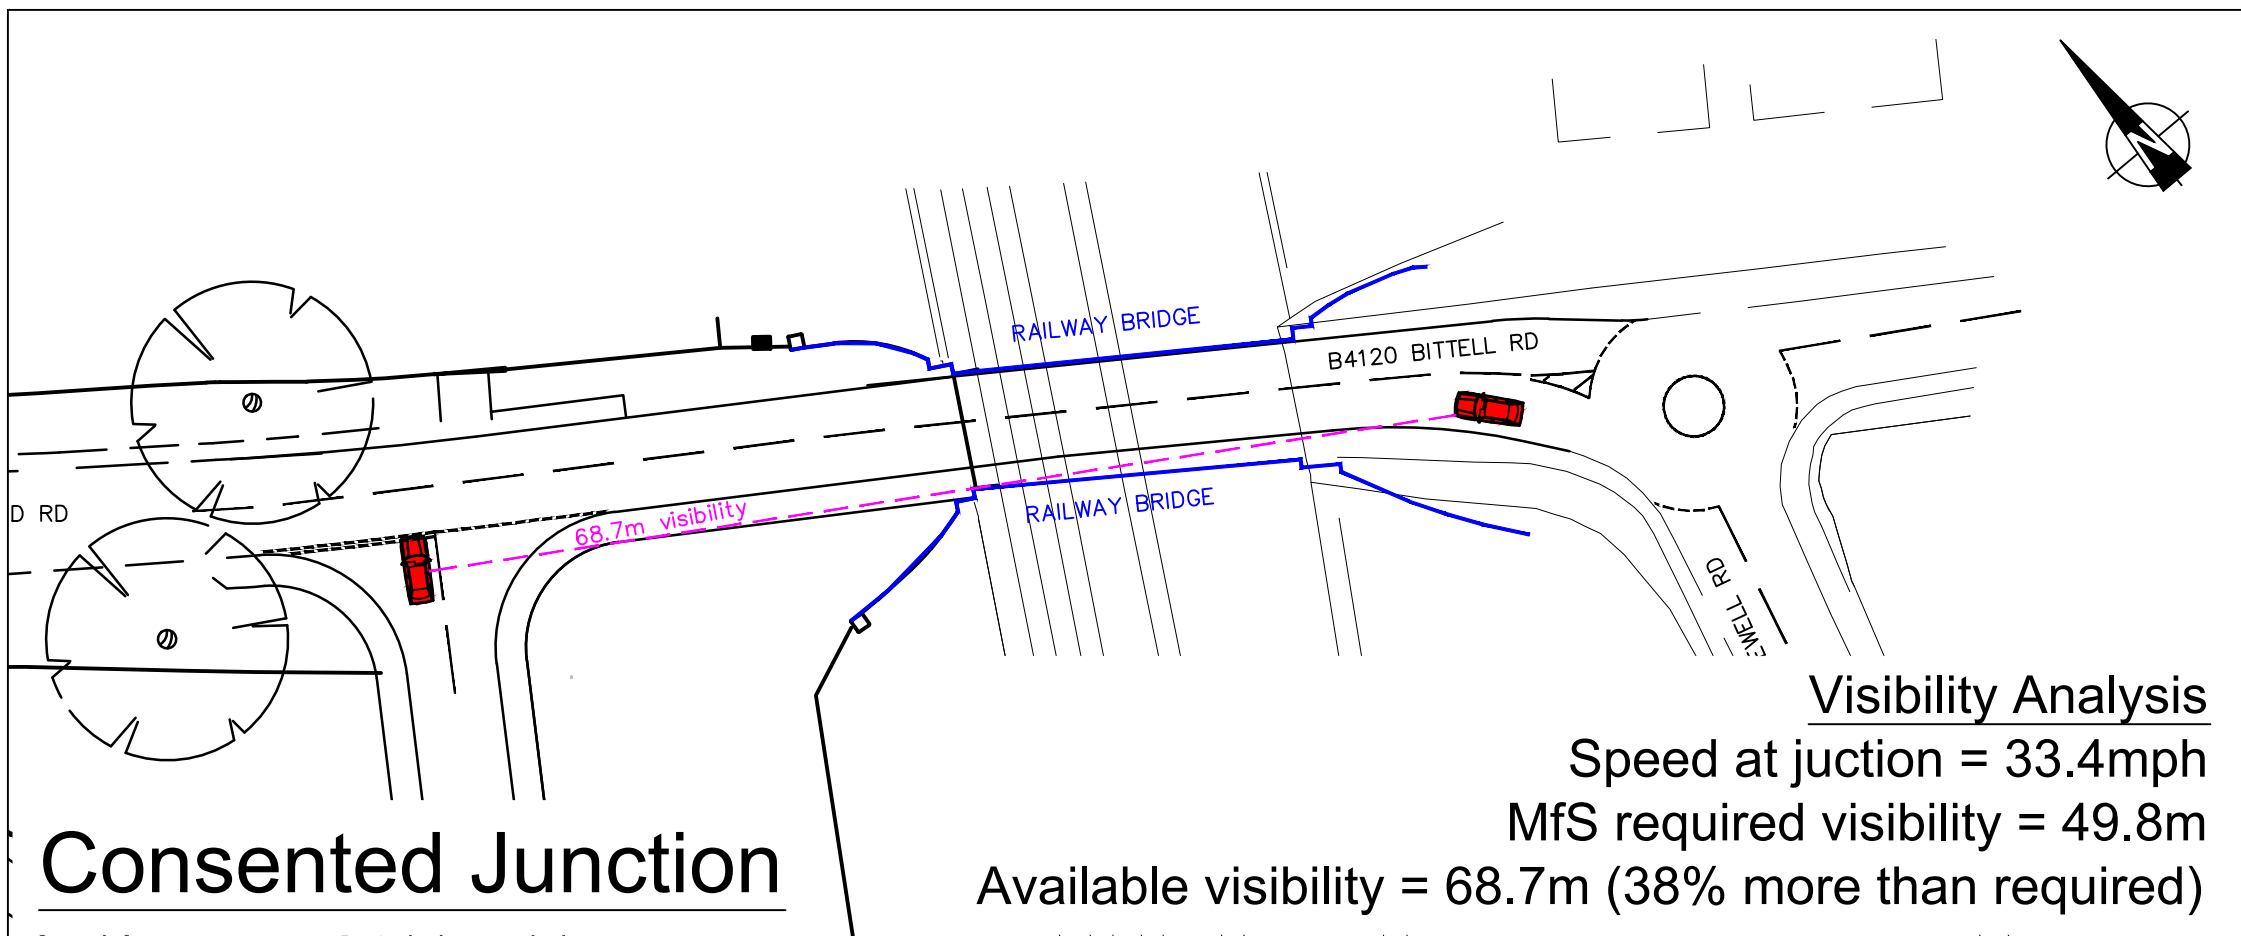
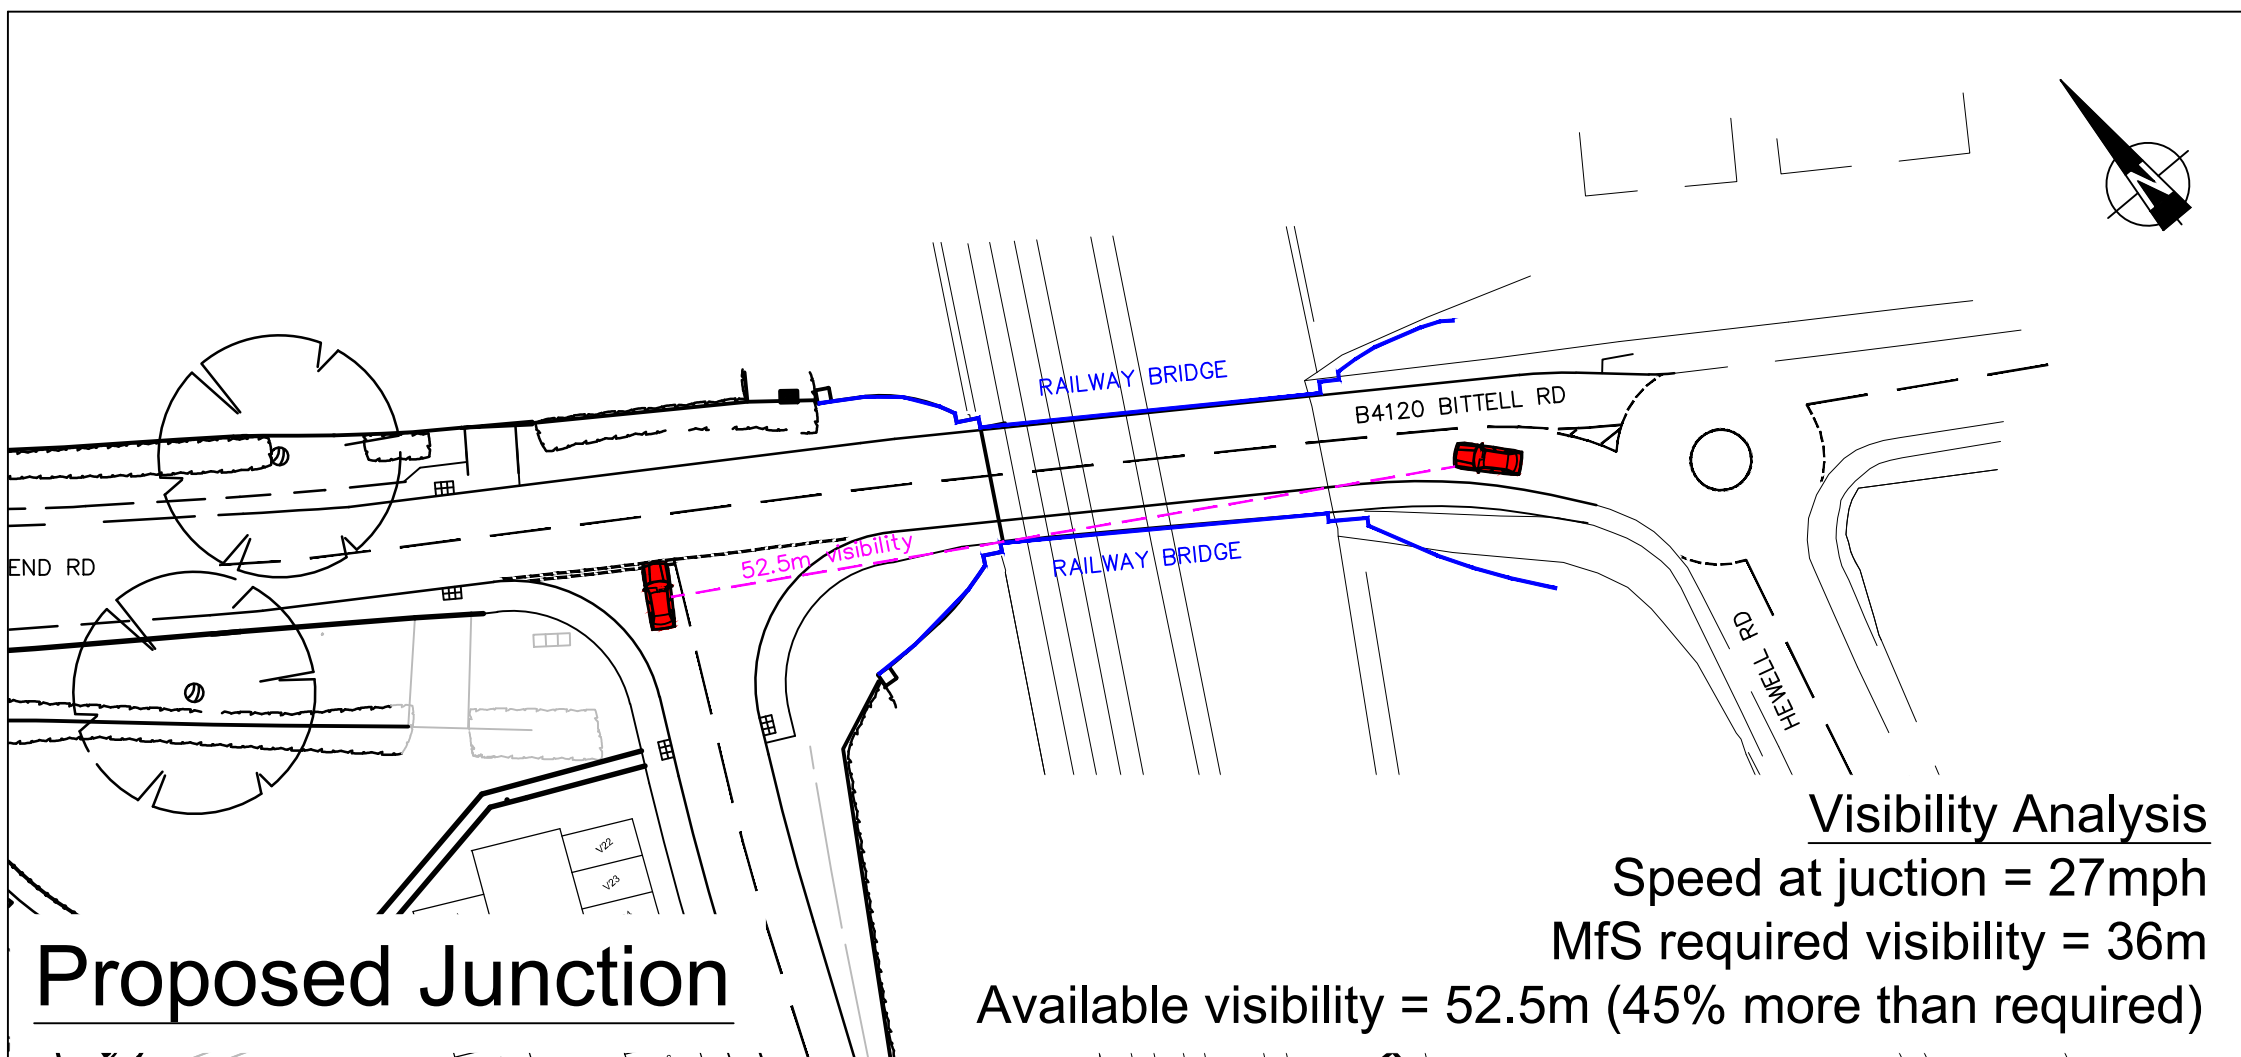
CALA House Arleston Way Solihull B90 4LH Tel: 0121 711 5310 Fax: 0121 711 5311	
Site: Land off Fiery Hill Road Barnt Green			
Drawing Title: Fiery Hill Road Realignment Junction Visibility Analysis			
Drawing No: M00311/S278/103			
Revision: -		Scale: N.T.S @ A2	
Date: 15.12.2015		Drawn: CB

- 6.5 All surveys have been reviewed and it has been concluded that all three surveys are within the an acceptable tolerance for a range of surveys taken over a number of days.
- 6.6 The relocation of the realignment of Fiery Hill Road could be considered safer as vehicle speeds past the relocated junction will be slower.
- 6.7 Latest survey data identifies a 7 day 85th percentile speed of traffic approaching Fiery Hill Lane from the bridge as just 27mph.
- 6.8 The survey also shows and 10-year traffic flow of over 29 million vehicles and just one PIA, demonstrating just how safe the junction is in reality rather than perception.
- 6.9 The proposed junction provides a greater percentage of visibility (available over required) than the consented scheme.
